CORRECTIVE MEASURES CONSTRUCTION REPORT

SWMU 52D – HORSE STABLE AREA

Tooele Army Depot
Tooele, Utah

Draft Final

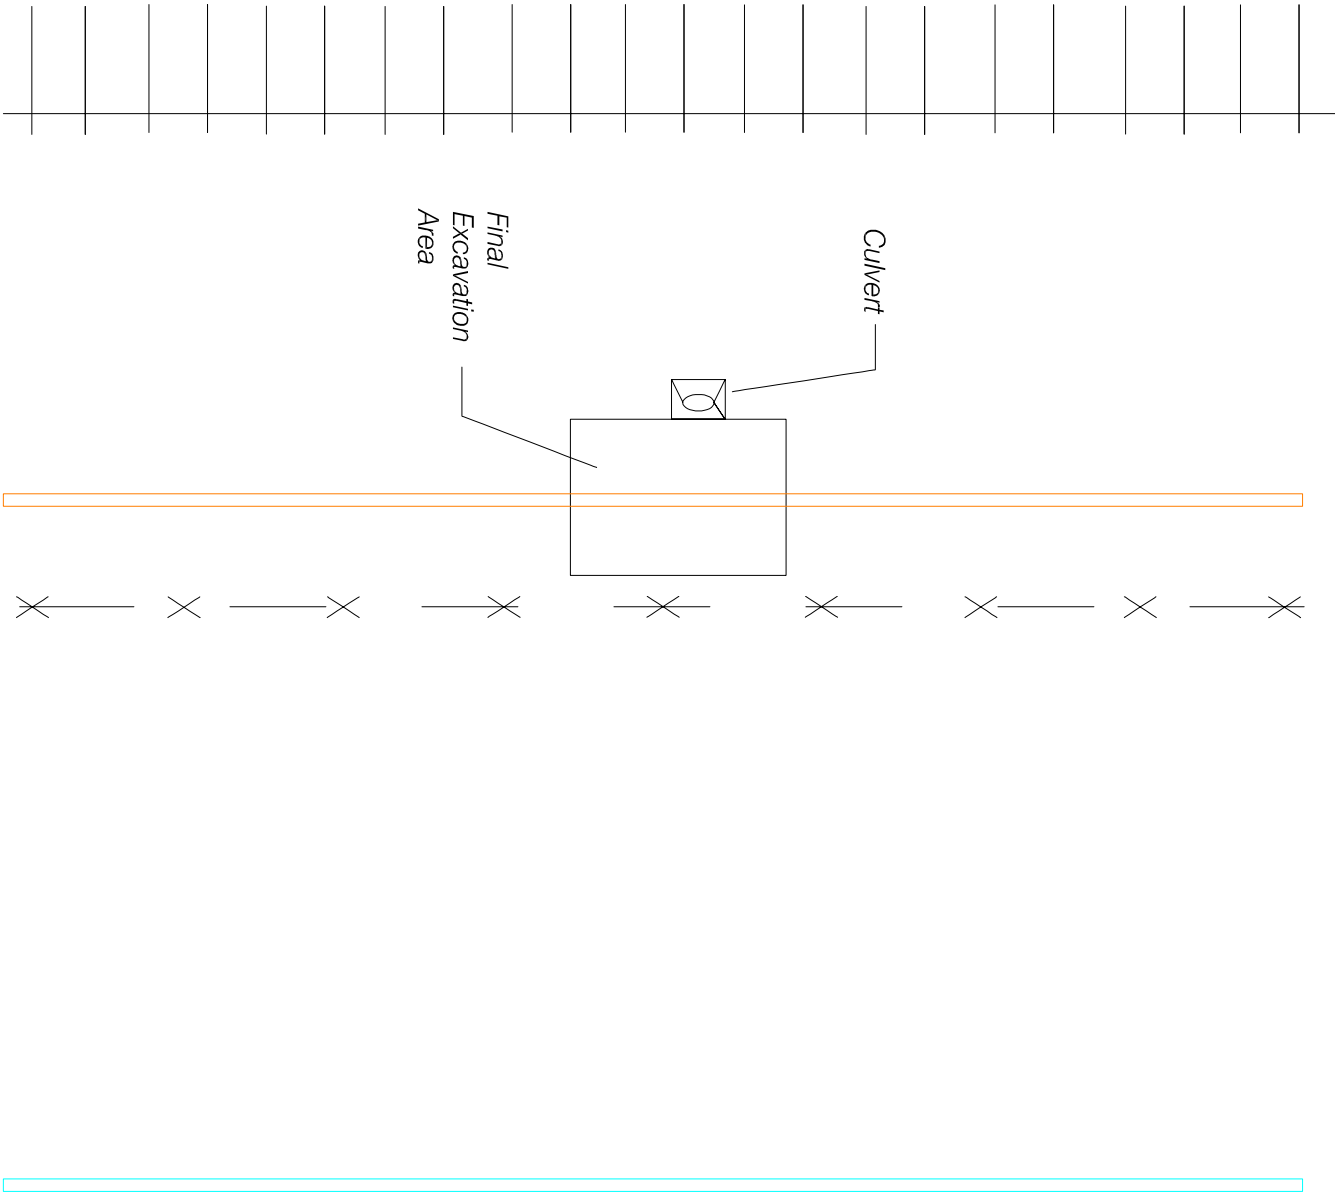
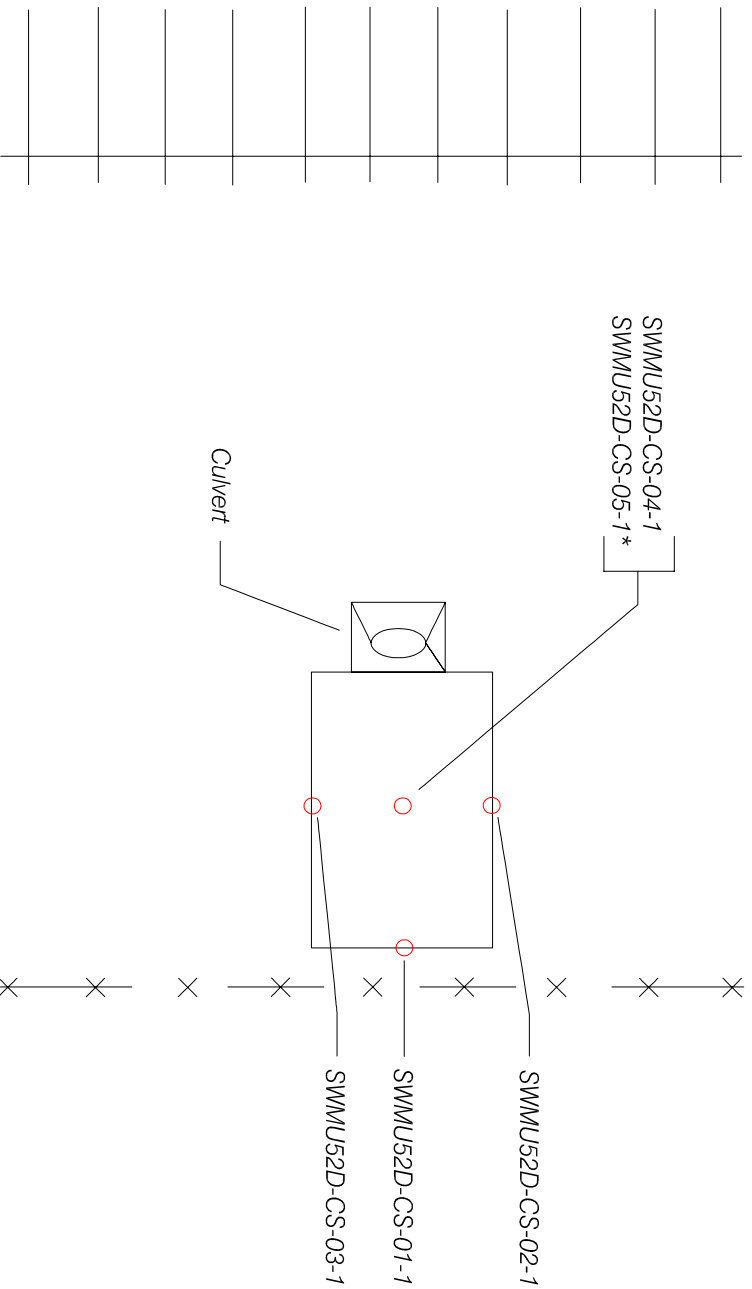
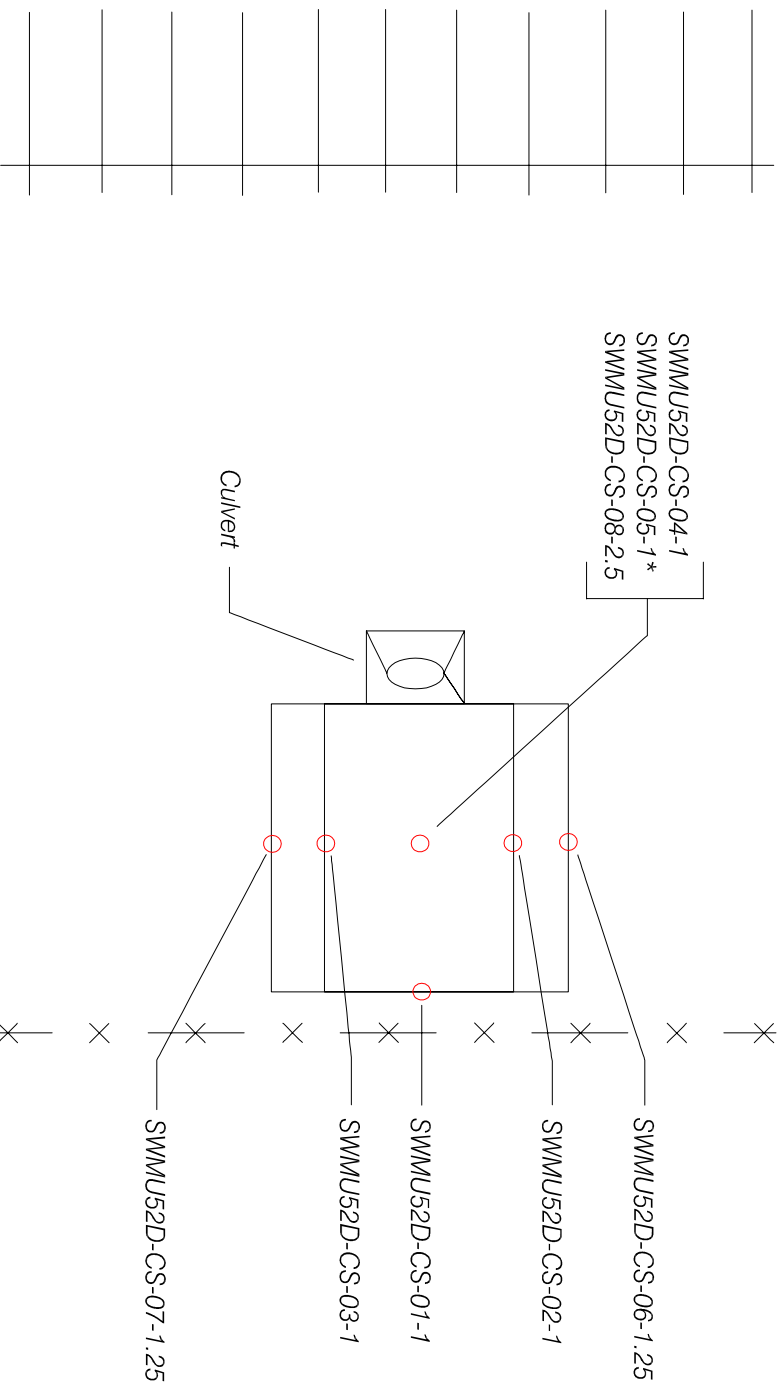
TOP VIEW

SIDE VIEW (FROM EAST)

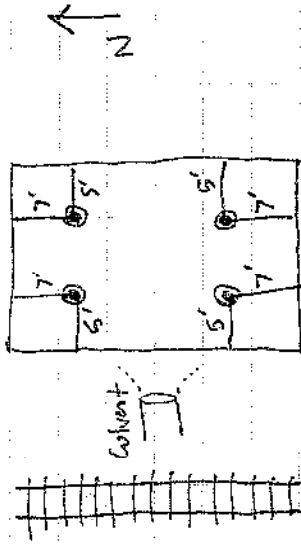
Location of 4-pt. composites:

for SWMU52D-CS-10-4.5 and
" " -19-4.5 (QC)

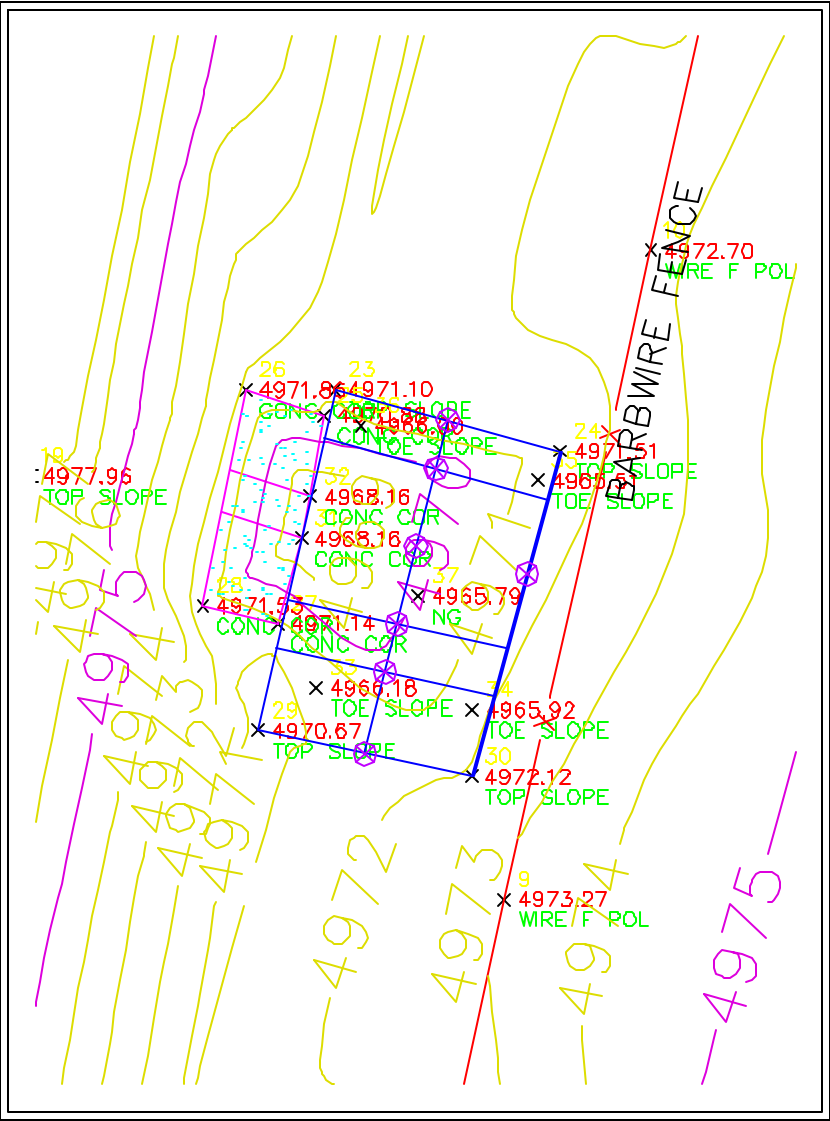
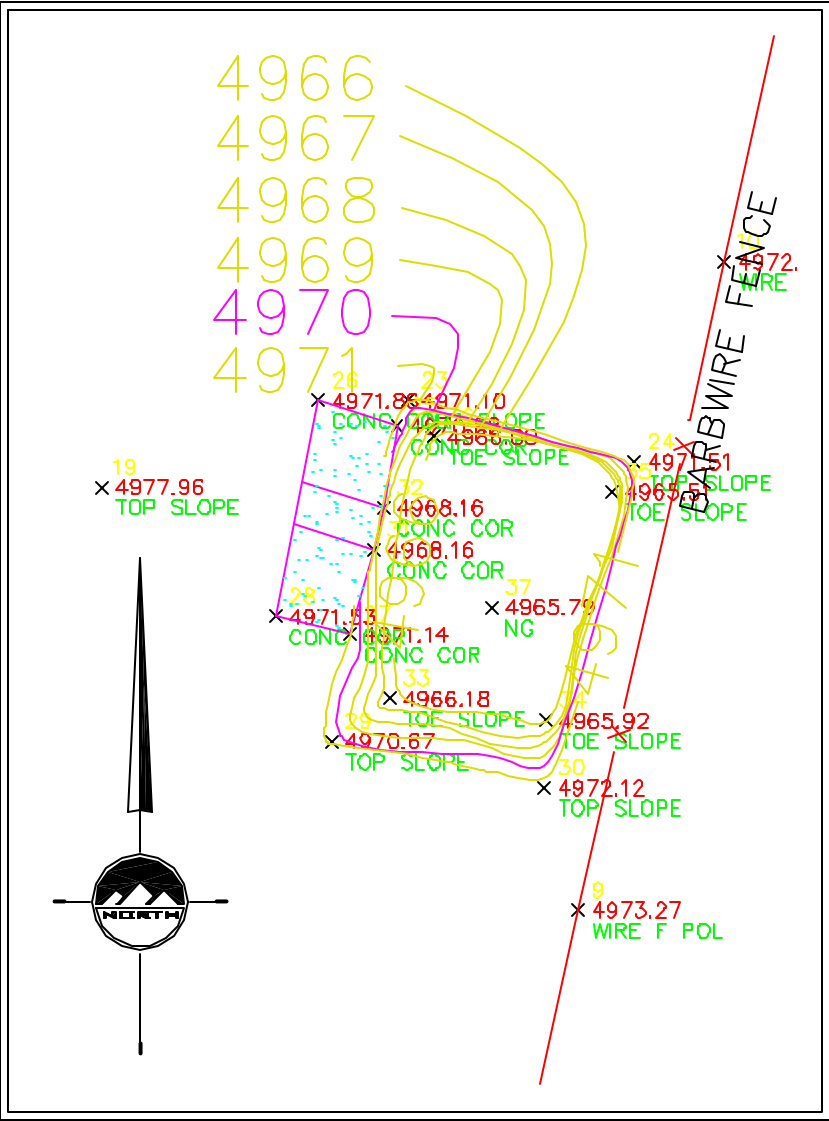
COMPOSITE VOLUME
NET=36 YARDS OF SOIL REMOVED FROM SITE

SURFACE BEFORE EXCAVATION

SURFACE AFTER EXCAVATION

VOLUMES CALCULATED ARE BASED ON
INFORMATION GATHERED IN THE FIELD AFTER
THE EXCAVATING WAS COMPLETED.

SURFACE BEFORE EXCAVATION CONTOURS
ARE ESTIMATED BASED ON EXISTING
UNDISTURBED GROUND.
